Single Cable Capsule Systems in Contrast to Twin Fall Lifeboats

Marine Accident Investigation - Improving Evacuation Systems' Safety

Lifeboat Incident Survey - 2000

*Results from a Joint Industry Survey carried out
by
OCIMF, INTERTANKO AND SIGTTO*

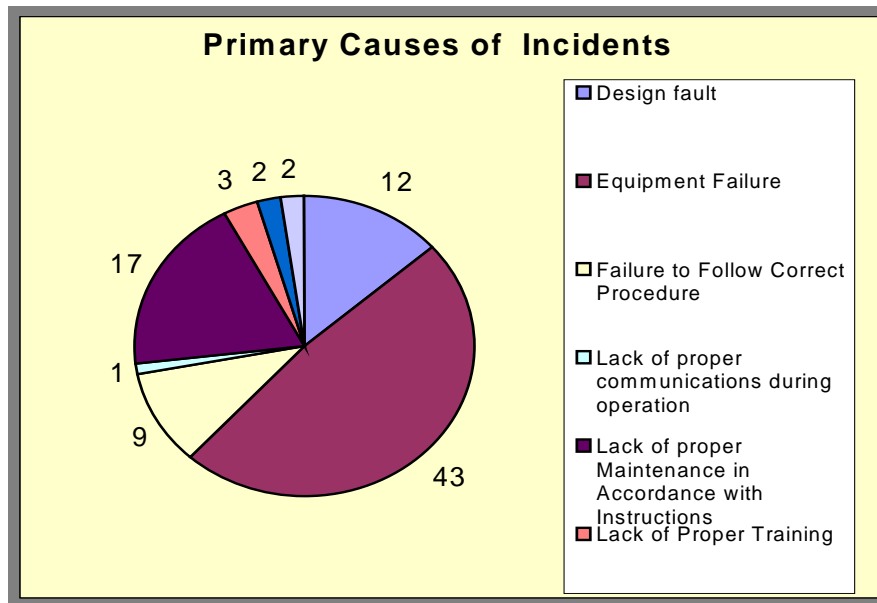
Primary Causes of Incidents

Equipment failure is the greatest cause of incidents in all categories, followed by lack of proper maintenance, design faults and a relatively small number of Procedural faults.

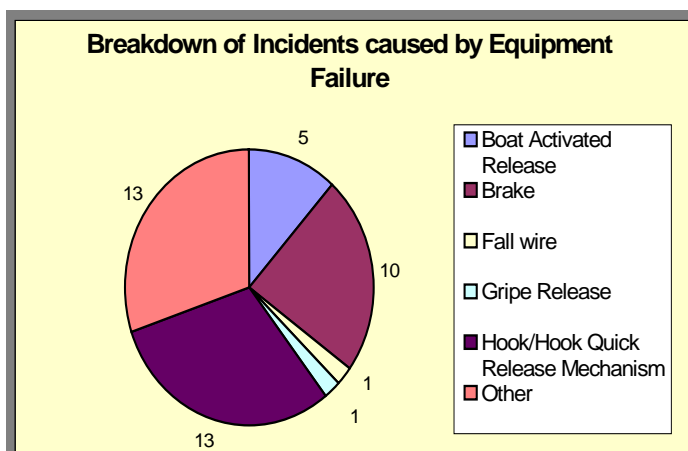
Equipment Failure

Hook/Hook Quick Release Mechanism failure is the largest group, relating to inability to engage or release hooks correctly due to cable failure or mislocated safety mechanisms.

Other major types of failure are winch brake related, caused by internal mechanism or remote controls for brake releases.

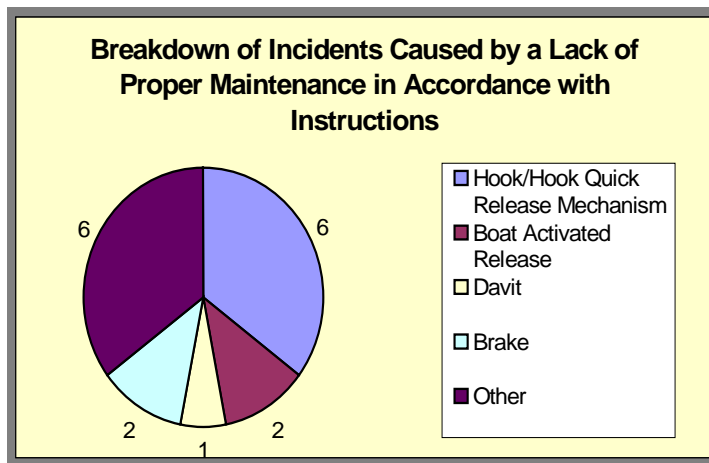
Lack of Proper Maintenance

Problems with Hook/Hook Quick Release Mechanism top this grouping. Usually attributable to wastage of critical parts within safety mechanisms.

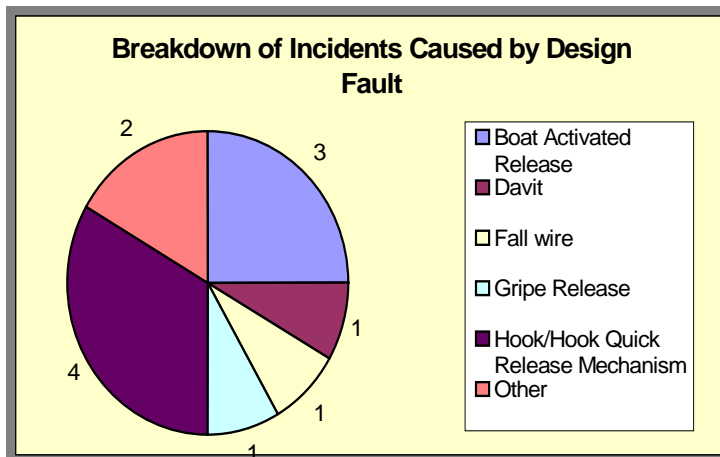
Design Faults

Again, the majority of incidents have occurred with Hook/Hook Quick Release Mechanisms followed closely by Boat Activated Release. The Lifesaving Role of the lifeboat may be compromised by an inability to launch it

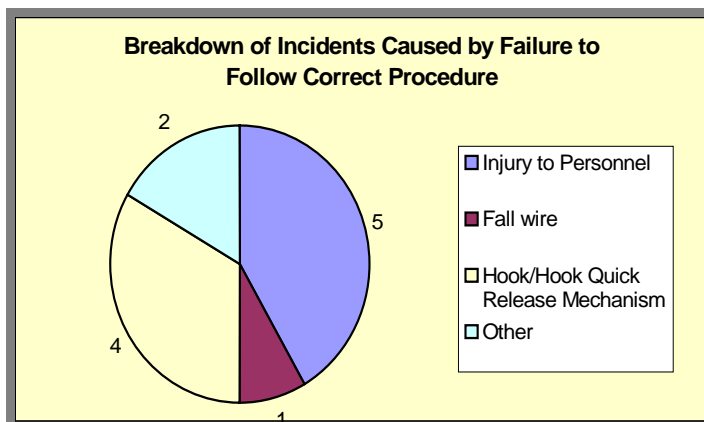
Failure to Follow the Correct Procedure

A number of incidents from failure to follow the correct procedure resulted in injury to personnel. Others resulted mainly in damage to boat or launching apparatus. Again, the Hook/Hook Release Mechanism is a substantial contributor to this type of incident.

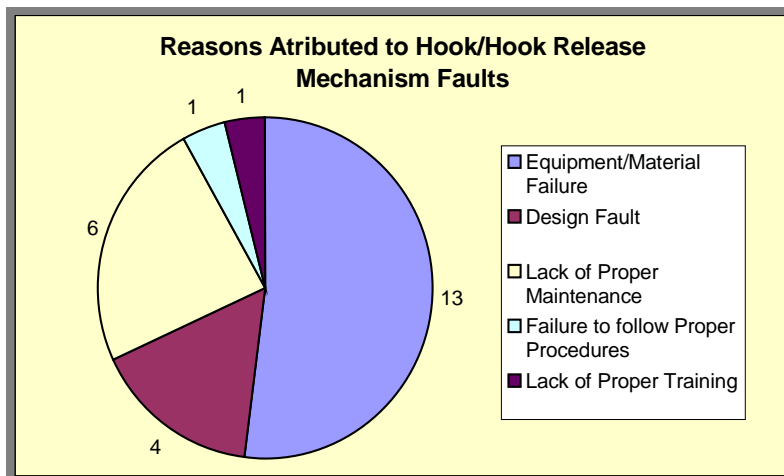
Hook/Hook Quick Release Mechanisms

As previously noted, incidents attributed to faults with the Hook/Hook release Mechanism are the greatest single group. Of these 25 incidents, over 50% are due to failure of the equipment or of the material. When

Design Fault is added some 68% of these incidents can then be grouped as a single "Design factor". If at the design stage the requirement for non-critical maintenance was addressed, the incidents categorised under Lack of Proper Maintenance may not have occurred. Therefore, all but 2 of these incidents can be attributed to poor design of the Hook/Hook Release Mechanism.

- Review maintenance procedures in light of these reported incidents. Particular component failures to consider are: -
 1. Hook/ Hook release mechanisms to be inspected to ensure that all components are within tolerance, there is no build of scale, and that there is no wastage that could either weaken the equipment or cause it to operate incorrectly. This includes the release cable, which has been subject to a number of incident reports.
