Single Cable Capsule Systems in Contrast to Twin Fall Lifeboats

Marine Accident Investigation - Improving Evacuation Systems' Safety

Lifeboat Incident Survey - 2000

*Results from a Joint Industry Survey carried out
by
OCIMF, INTERTANKO AND SIGTTO*

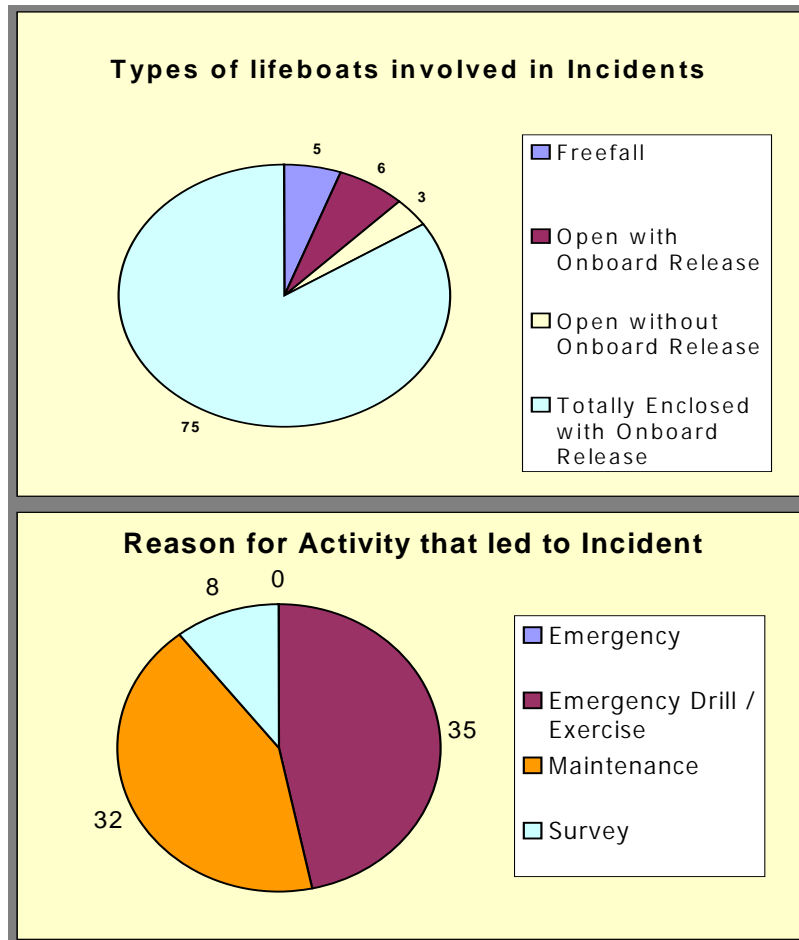
The charts below show the proportions of different lifeboat types involved in the reported incidents.

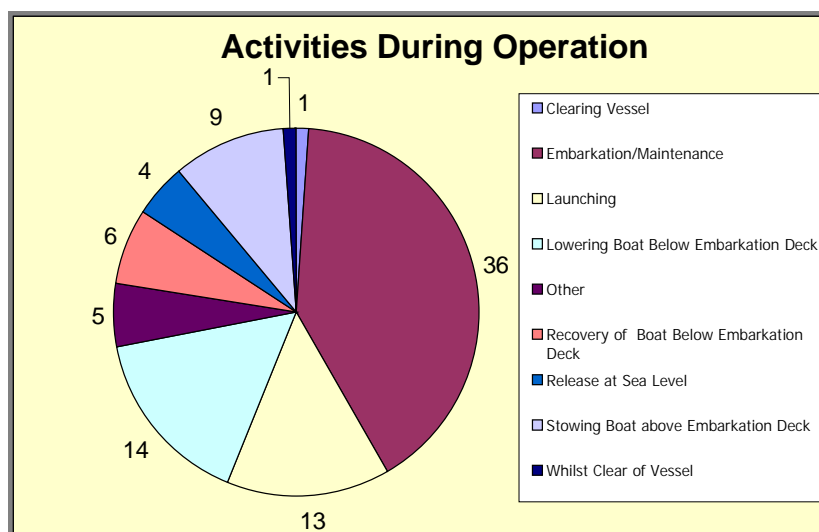
All reported incidents were associated with either testing or maintaining the boats, training exercises/drills or Surveys.

The majority of incidents involved personnel being within the boats.

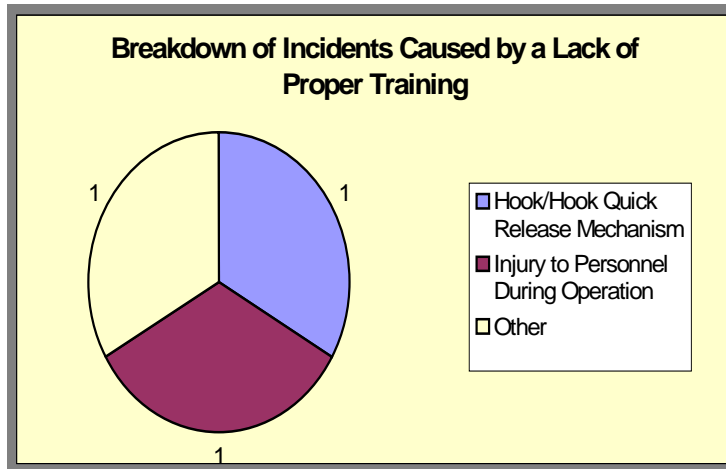
Few incidents can be attributed to lack of proper training and no valid conclusion can be drawn.

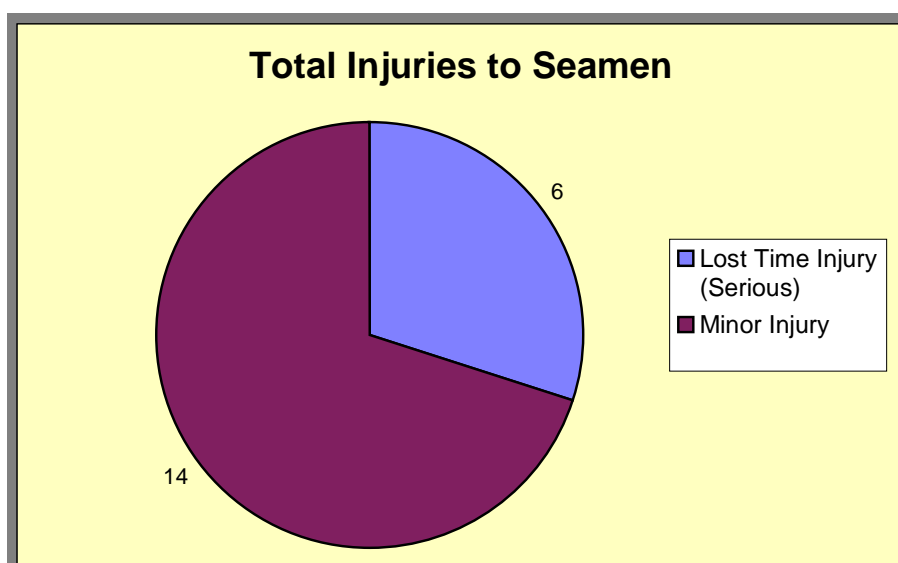
The number of injuries in comparison with the number of incidents is low. It can be assumed that a deep mistrust of lifeboats has developed on board vessels, resulting in operation of the boats in a manner that limits as much as possible any exposure to potential injury, such as a minimum number of persons in the boats when being lowered and lifted.

20 injuries were reported, 6 being serious, requiring at least several days off work and 14 were minor, requiring first aid or medical treatment before continuing work.

These 20 injuries occurred in 13 separate incidents, 4 of which accounted for the serious injuries.

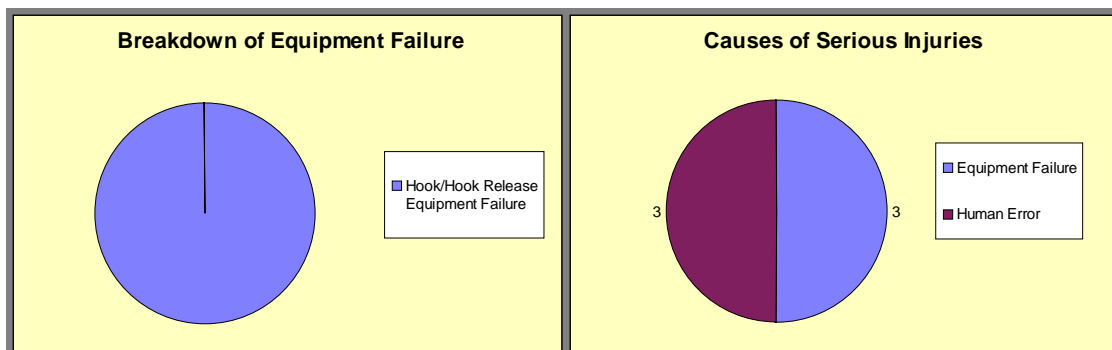
Serious Injuries

- A major incident was a lifeboat releasing itself and falling to the water from the embarkation deck level. The height above the water was relatively small at 12 metres and three members of the lifeboat crew incurred leg and/or back injuries. Had the freeboard been greater, fatalities would have been likely.
- The other incidents were all caused by human error - failure to follow correct procedure or lack of proper training. These included a thumb crushed by a closing lifeboat door and wrist fracture whilst starting a lifeboat engine.

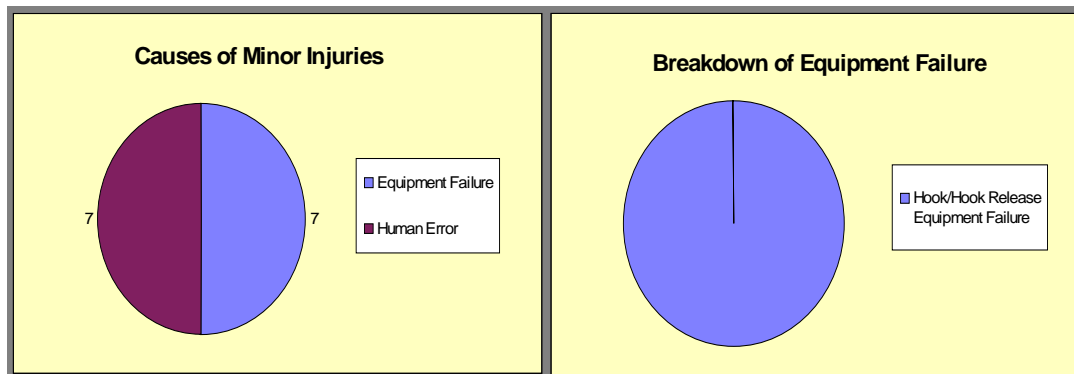
Minor Injuries

9 incidents involved minor injury. Two had potential for serious injury: -

- During a boat launch, the forward quick release hook released itself with the boat five metres above the waterline. This resulted in minor injuries to 4 seamen. The nature was not reported but the potential for more serious injury existed.
- A lifeboat was lowered to sea level but the launch aborted when one hook did not release. The other released but was reconnected and the boat recovered above embarkation deck with the crew onboard. When the boat reached the davit head the hook that failed released itself, resulting in the boat swinging from one fall. The three crew received cuts and bruises. Great potential existed for serious or fatal injuries. The one fall and davit proved sufficiently strong to hold the total weight of the boat on this occasion.

- Some incidents include injuries incurred whilst attempting to “hook on” to the falls for boat recovery. In one incident a seaman was struck by the swivel block and in the other a seaman incurred pinch cuts to his hands whilst holding the hook in place as the release system was engaged. The connection of waterborne lifeboats to falls has always proven a hazardous operation, but is exacerbated by release mechanisms which are difficult to engage correctly. A similar minor injury was incurred when trying to reconnect a quick release hook after maintenance. This resulted in cuts to fingers.

- Other incidents include gripe releases under tension where a seaman was struck heavily by the freed end of the gripe and one where a seaman caught his finger in the gripe release mechanism.

- More minor incidents include a seaman attaching his safety harness to the davit and being pulled off balance when the davit was lowered and a seaman losing balance whilst attempting to start a lifeboat engine. The seaman struck his head, rather than fracturing a wrist as noted in Serious Injury section.
